UNITED STATES COAST GUARD

**MARINE BOARD OF INVESTIGATION INTO THE
CIRCUMSTANCES SURROUNDING THE SINKING OF THE**

F/V KATMAI

**IN THE AMCHITKA PASS, NORTH PACIFIC OCEAN
ON OCTOBER 22, 2008, WITH MULTIPLE LOSS OF LIFE**

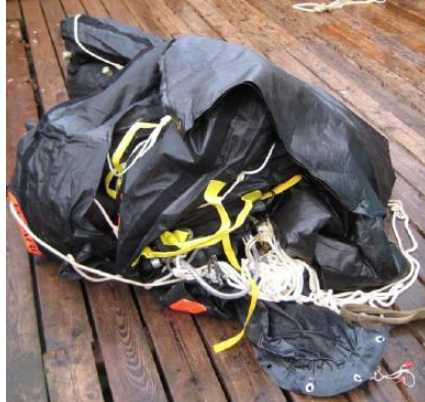
chambers and the canopy was missing. The servicing manual for the 10 person Crewsaver liferaft required that the valve assembly on the compressed gas cylinder be attached to the 90 degree elbow on the inflation hose with 30 ft-lbs of torque. The checklist used by the liferaft servicing facility to service this liferaft did not indicate that the ballast bags were inspected or that the compressed gas cylinder was verified to be attached in accordance with manufacturer's specifications. See Analysis section for more information regarding the F/V KATMAI liferafts.

Recovered F/V KATMAI Liferaft

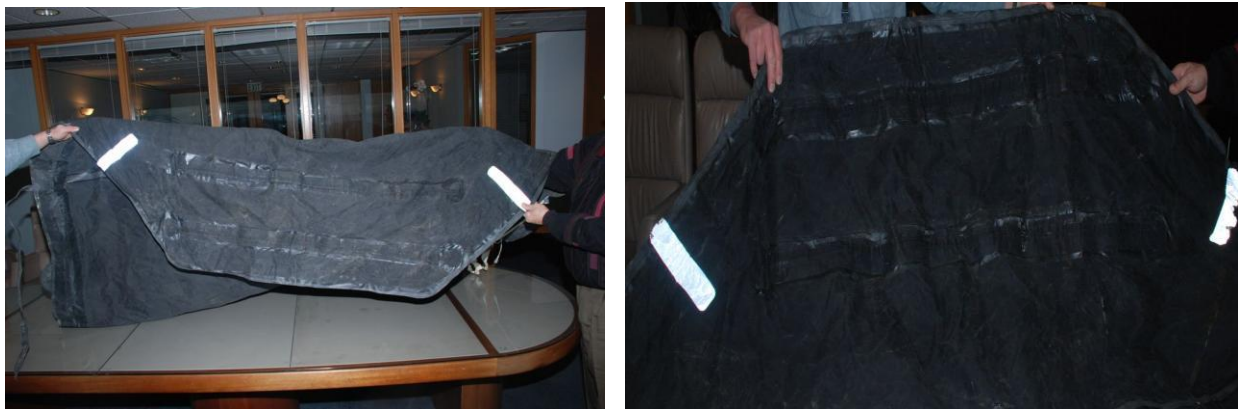
Ballast bags should have been attached to the floor of this liferaft. 46 CFR 160.051-4 (1994 Edition) required that "water pockets to improve stability and reduce drifting" be fitted on the underside of the liferaft floor. This liferaft was manufactured in 1994 and would have been required to comply with this regulation. An examination of the underside of the liferaft floor indicated that the ballast bags were missing from the liferaft floor. The two pictures below show where the two ballast bags should have been attached to the liferaft floor. Based on an analysis of the pictures below, the liferaft manufacturer stated the ballast bag on each side would have been approximately 48" long with each holding approximately 3.5 cubic meters of water.

Missing Ballast Bags on Bottom of Liferaft Floor

The high seas experienced on October 22, 2008 may have pulled the ballast bags off of the floor of the liferaft but there are minimal indications of tearing. The following picture shows the stitching that connects the ballast bag to the liferaft floor. The stitching was intact but an examination of the remaining ballast bag material was inconclusive as to whether the ballast bags were torn off of the liferaft from exposure to the high seas or if they were manually cut/ripped off from the liferaft. Both ballast bags were completely removed from the liferaft making it difficult to determine if the ballast bags were properly attached prior to the casualty. Based on a review of the checklist used to service this liferaft in 2007, there is no indication that the servicing technician inspected or verified the proper installation of ballast bags on this liferaft.

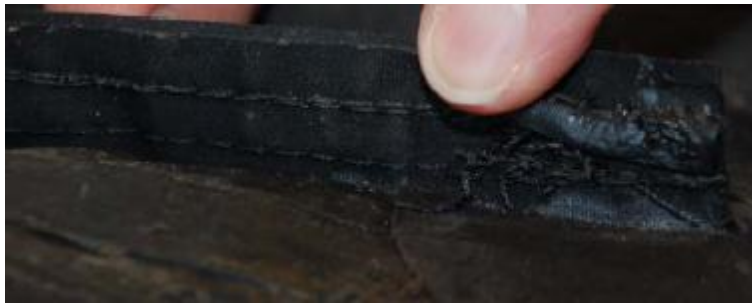
Ballast Bag Connection to Liferaft Floor

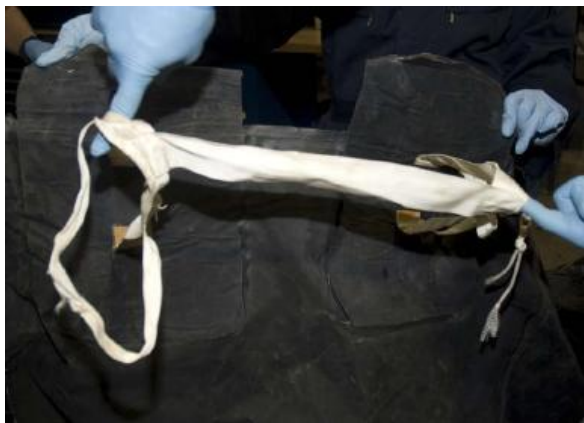
The compressed gas cylinder should have been attached to the liferaft in the cylinder harness. The compressed gas cylinder was missing when the liferaft was recovered by the crew of the FPV COURAGEOUS on October 22, 2008. The following pictures show the cylinder harness on the recovered liferaft and also a picture of a similar harness with a compressed cylinder inserted into the harness.

Recovered Liferaft Gas Cylinder Harness

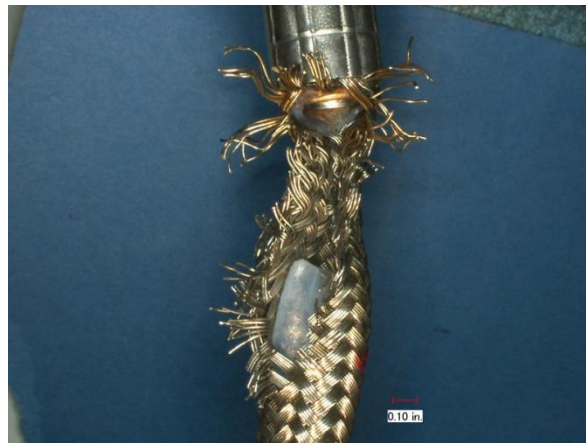
damage and elongation discovered on the inflation hose. The following picture shows that the elongation of the inflation hose caused the Teflon liner to rip at the end that was crushed causing a hole in the hose.

Torn Teflon Liner of Inflation Hose

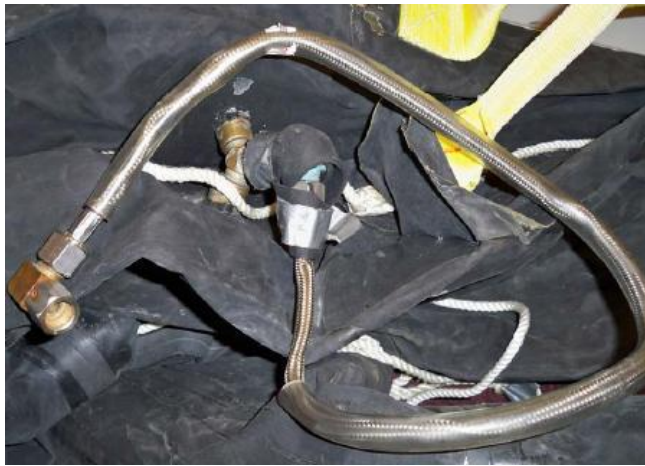
The presence of these particles does not indicate whether or not the 90 degree swivel elbow was properly attached to the inflation valve assembly on the compressed gas cylinder following the servicing of the liferaft in December 2007. The 90 degree swivel elbow should have been attached to the inflation valve assembly with 30 foot-pounds of torque. This fitting was either not installed properly by the servicing facility or it was forcibly removed following the deployment of the liferaft either by hand or by the force of the seas. There is no evidence or testimony from the crew or vessel owner to indicate that either Crewsaver liferaft had been tampered with by the vessel owner or crew of the F/V KATMAI prior to being deployed on October 22, 2008.

Liferaft Inflation Hose

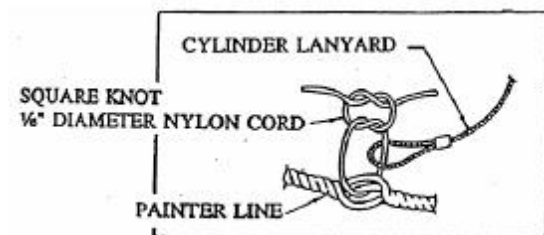
Figure 16: Cylinder Lanyard Attachment

The painter of the liferaft was examined and the nylon cord that would have attached to the cylinder lanyard as shown in Figure 16 was missing.

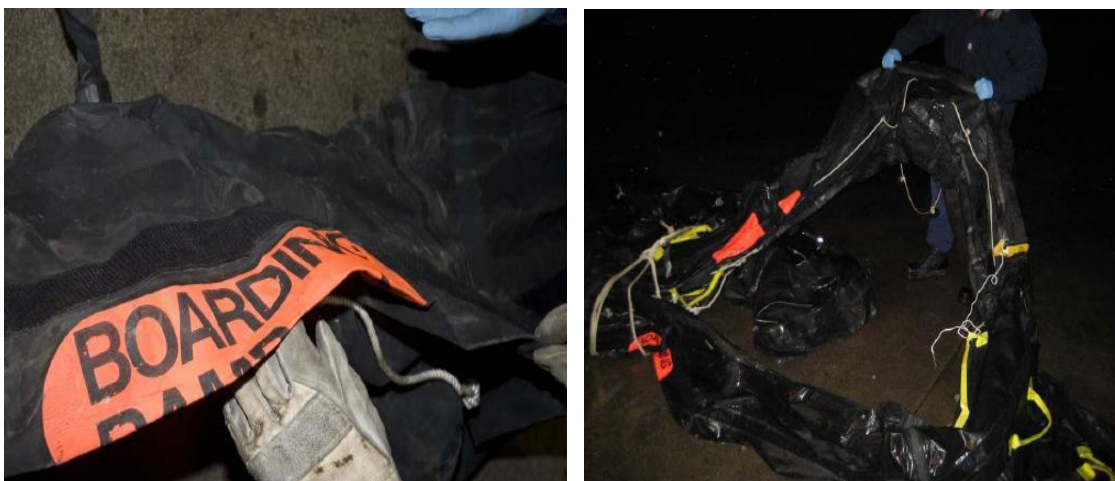
The liferaft hull was examined and did not appear initially to have inflated when it was deployed from the F/V KATMAI. The picture below shows the hull of the recovered liferaft in which the hull appears to be vacuumed similar to a liferaft stored in its container. However, a review of video footage from a Coast Guard search and rescue helicopter showed that both hull chambers of the liferaft had at least partially inflated when it was deployed from the F/V KATMAI. The condition of the liferaft hull when it was recovered was most likely a result from being tossed around in the rough seas.

Recovered Crewsaver Liferaft Hull

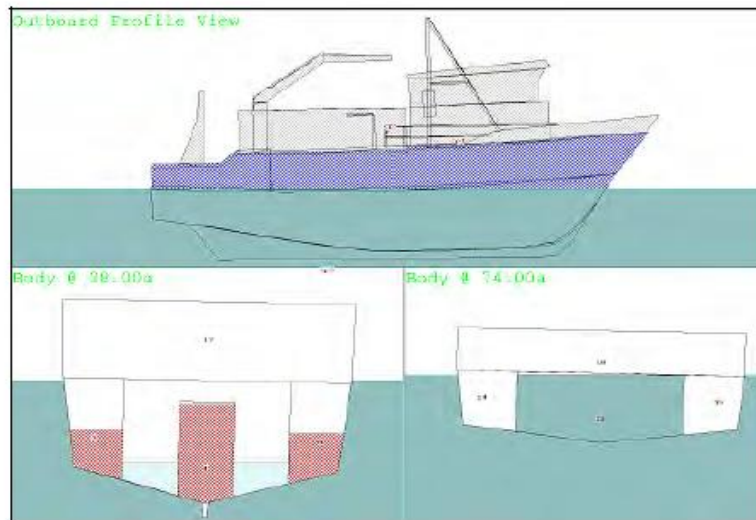
Figure (10). Step C in 1st flooding scenario

Step C is graphically shown in Figure (10). The model remained afloat with flooding of the lazarette space and water 2 feet above the deck plates in the engine room.

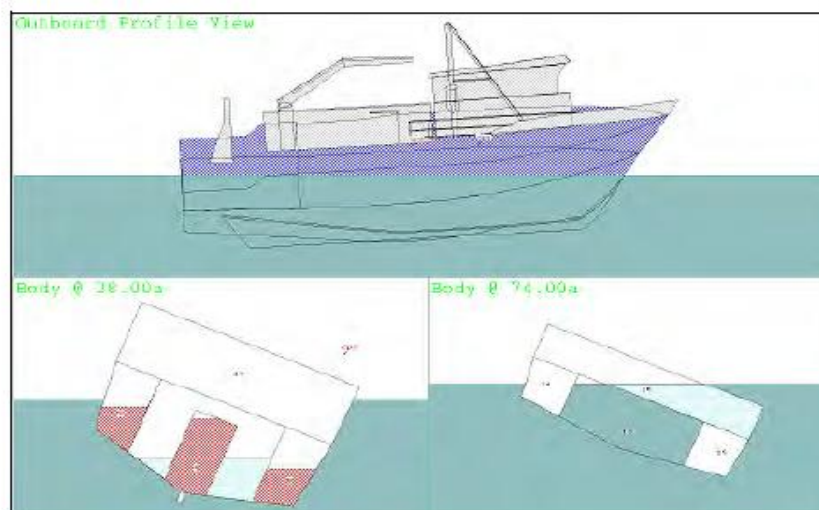
Figure (11). Step E in 1st Flooding Scenario

enough to enter these spaces through the downflooding locations. Figure (11) shows the model in this condition, which corresponds to Step E in Table (4).

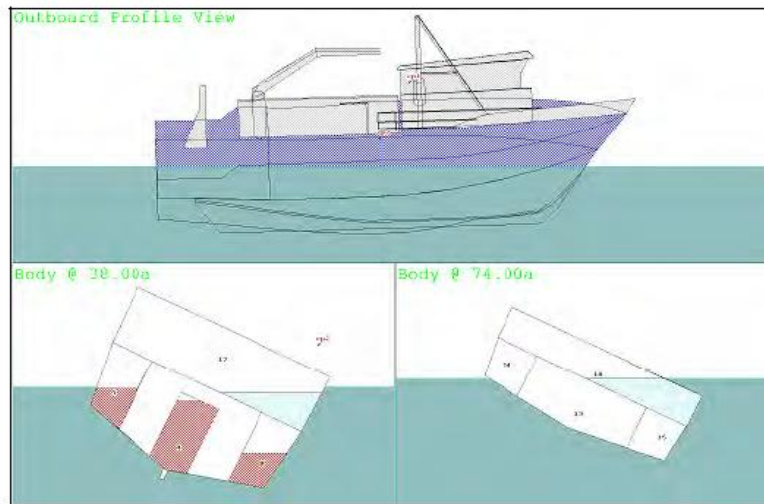
Figure (12). Step D in 2nd Flooding Scenario

Reference (a) indicated that the Chief Engineer reported that the flooding in the lazarette space and engine room was under control and going down. The flooding scenario in Table (5) examines the situation where the lazarette space and engine room have been pumped dry, but water was unable to drain from the aft bulwarks and water was starting to enter into the processing space through the reportedly open aft door into the space. As can be seen, even if the engine room and lazarette space were pumped dry and their buoyant volume restored, uncontrolled water entering the processing space led to the sinking of the model. Figure (12) shows Step D in the second flooding scenario with 6 inches of water in the processing space.

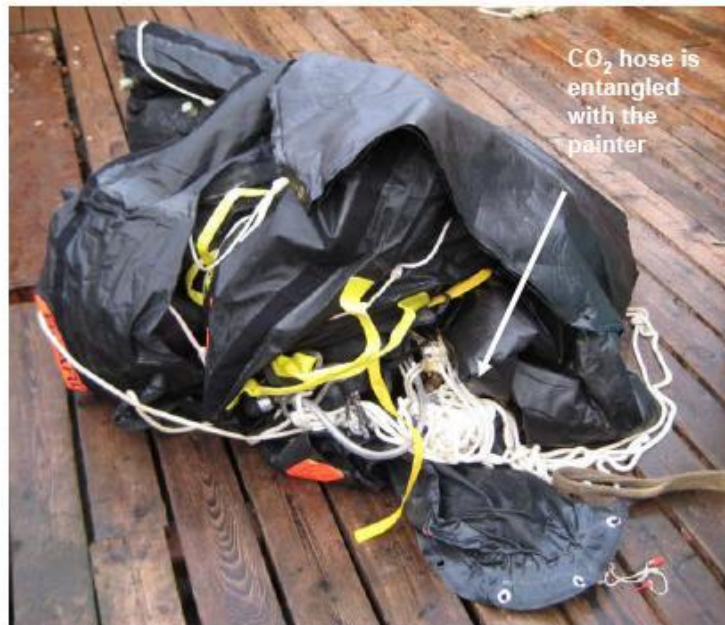
Figure 1. The un-inflated *Katmai* life raft as recovered on fishing vessel *Courageous*. The painter is a rope line that attaches the raft to the vessel and when pulled, it activates the inflation mechanism.

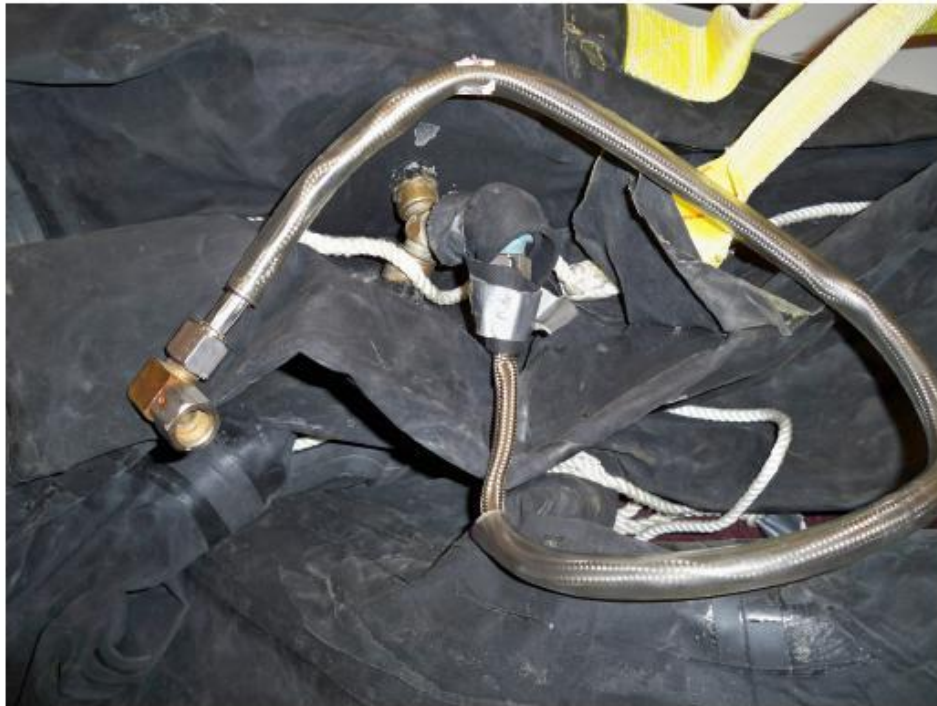
Figure 3. Image of the CO₂ inflation hose attached to the life raft fitting (painter is removed). No CO₂ tank was found with the life raft.

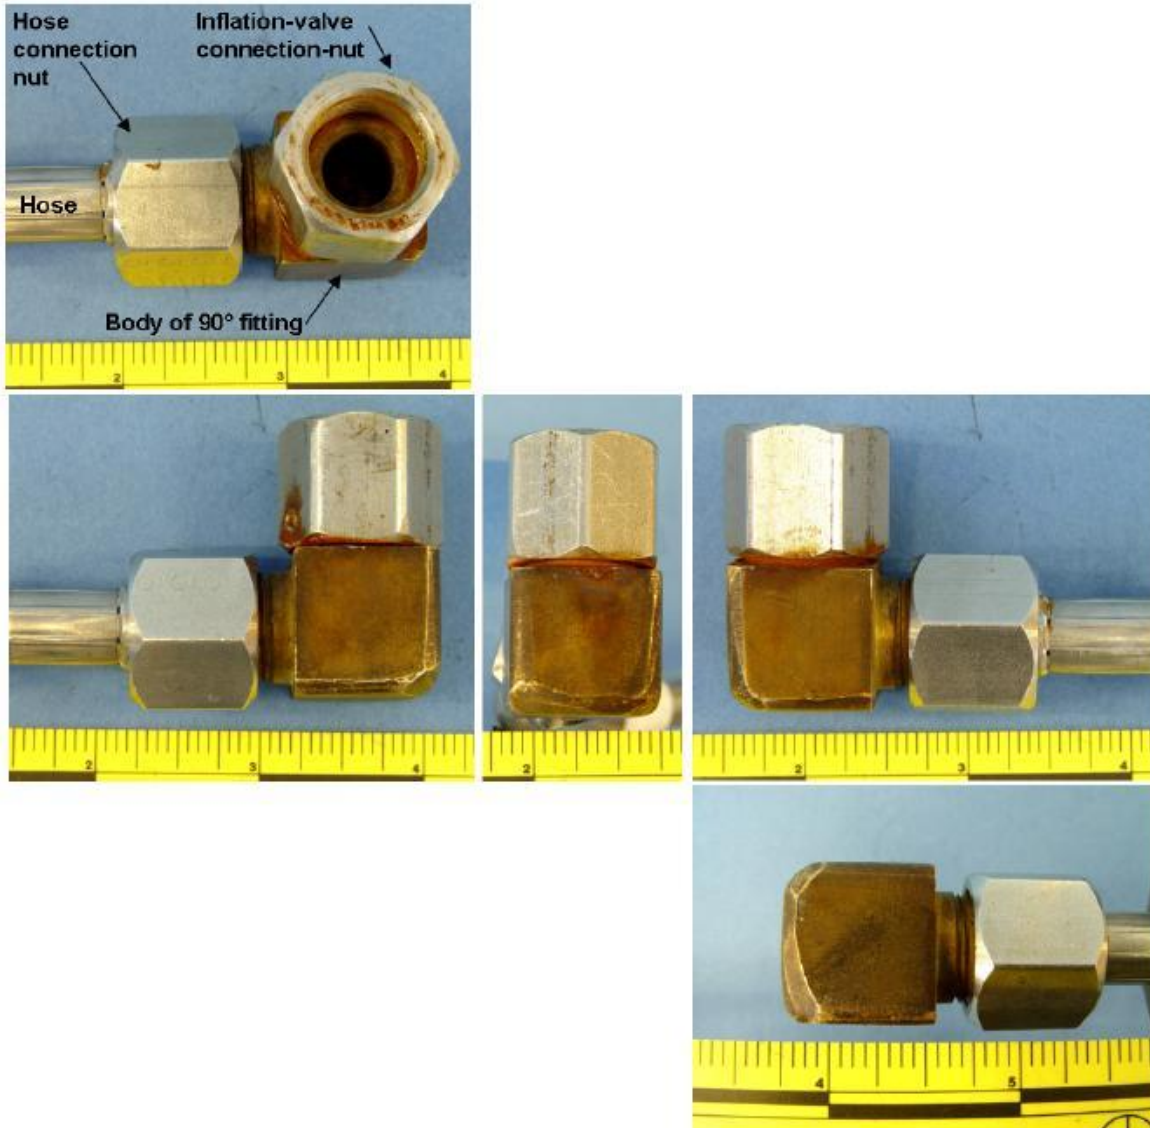
Figure 5. Photomacrographic details of the 90° fitting. Note the brownish-orange deposits at the interface surfaces between the inflation-valve connection-nut and the body of the 90° fitting.

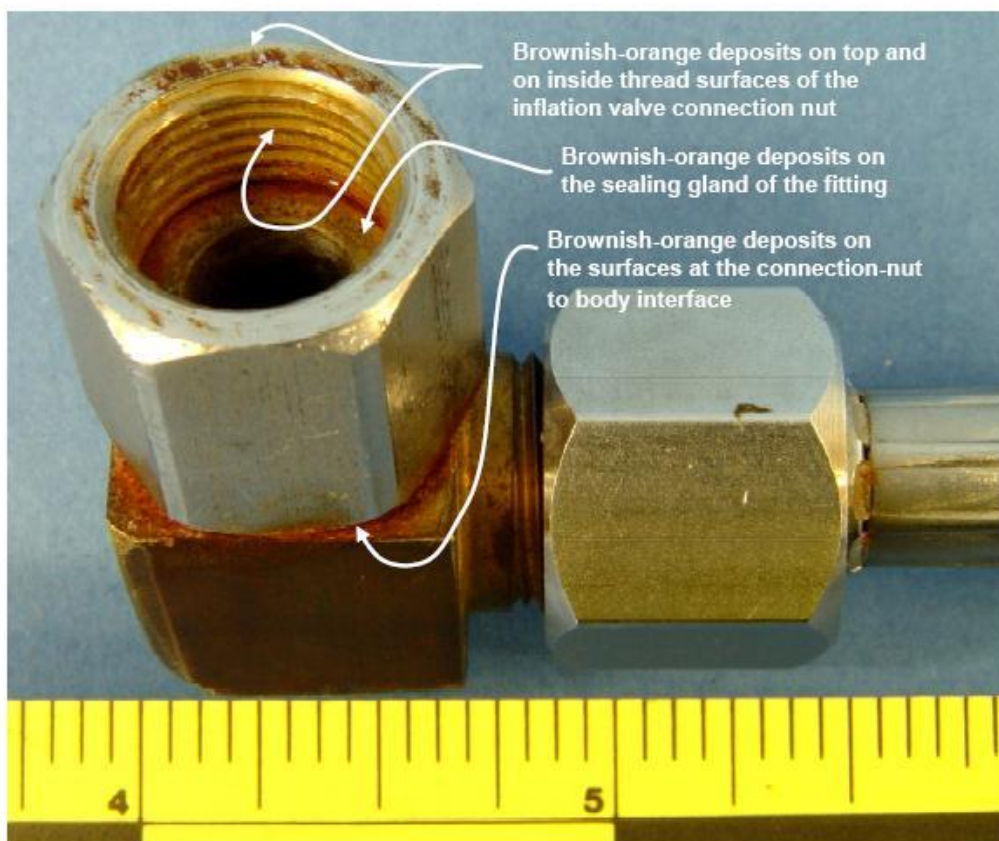
Figure 6. Close-up view of the 90° fitting. Note the brownish-orange deposits on the top and internal thread surfaces of the connection-nut and at the interface between the connection-nut and the body of the fitting.

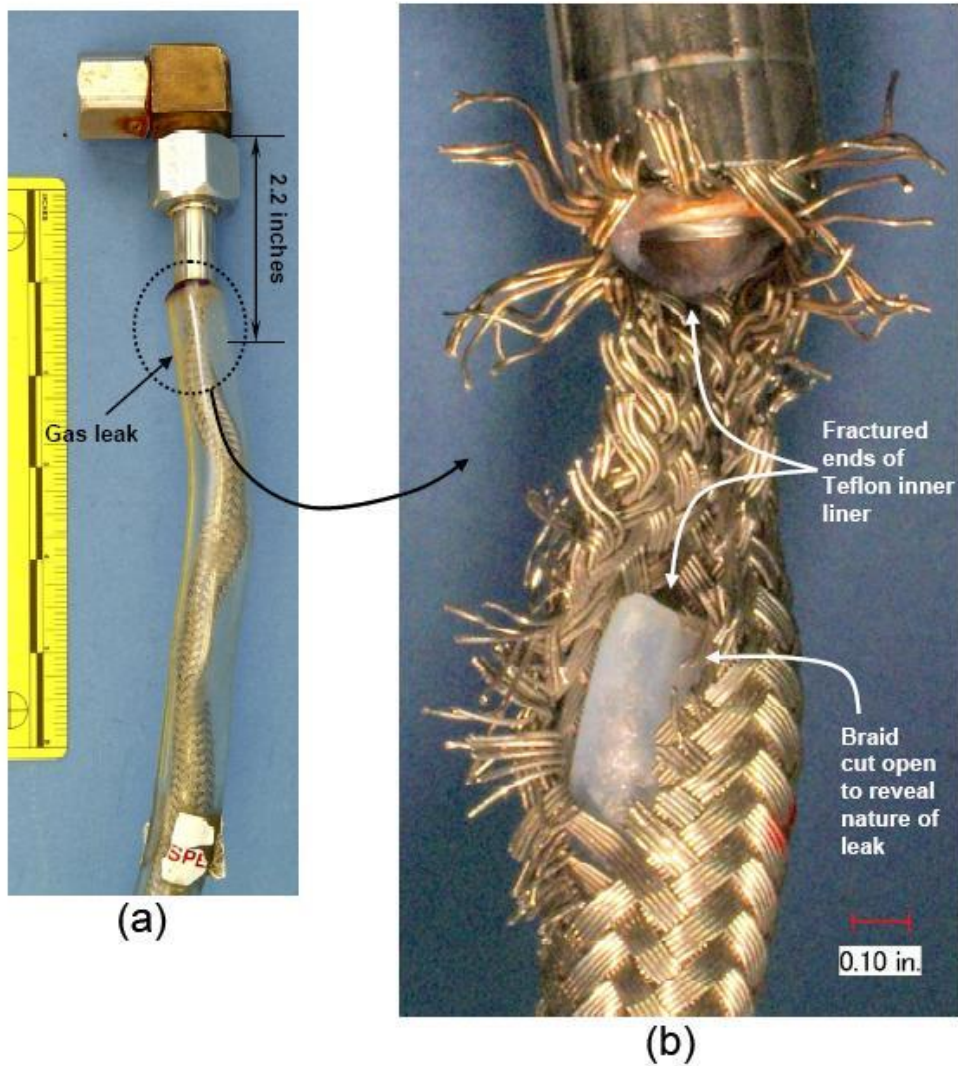
Figure 8. a) External location of the leak in the hose assembly. b) Rupture in the Teflon liner adjacent to the hose connector at the inflation-valve end of the hose.

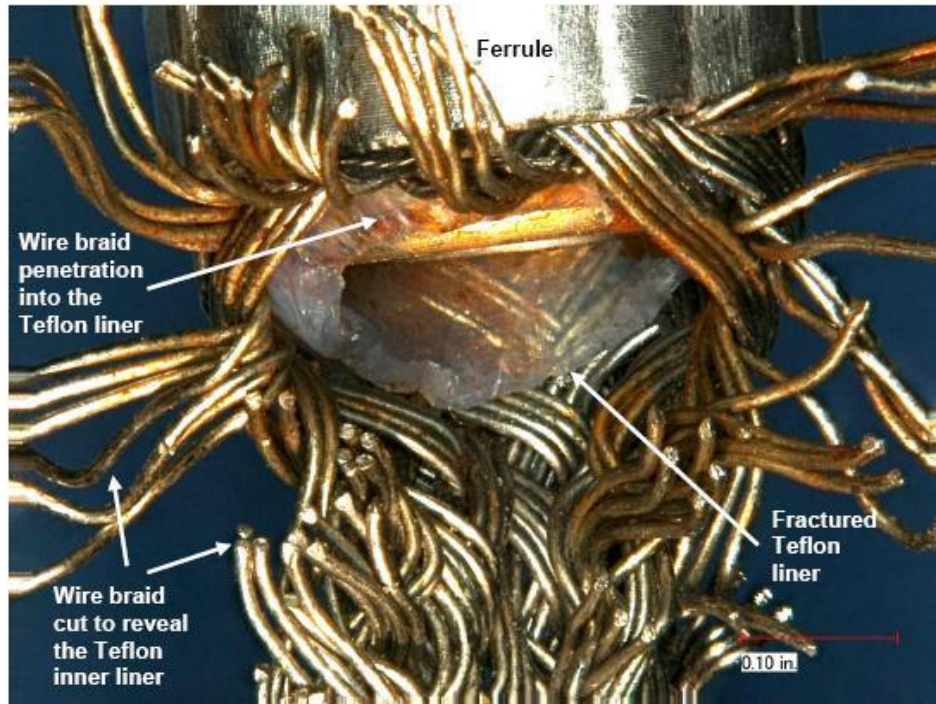
Figure 9. Higher magnification image of the Teflon liner fracture.
